I-94 East-West Corridor Study Visual Impact Assessment

PREPARED BY: Mark Greenig/CH2M HILL, Ben Goldsworthy/CH2M HILL
COPIES: File
DATE: September, 2014

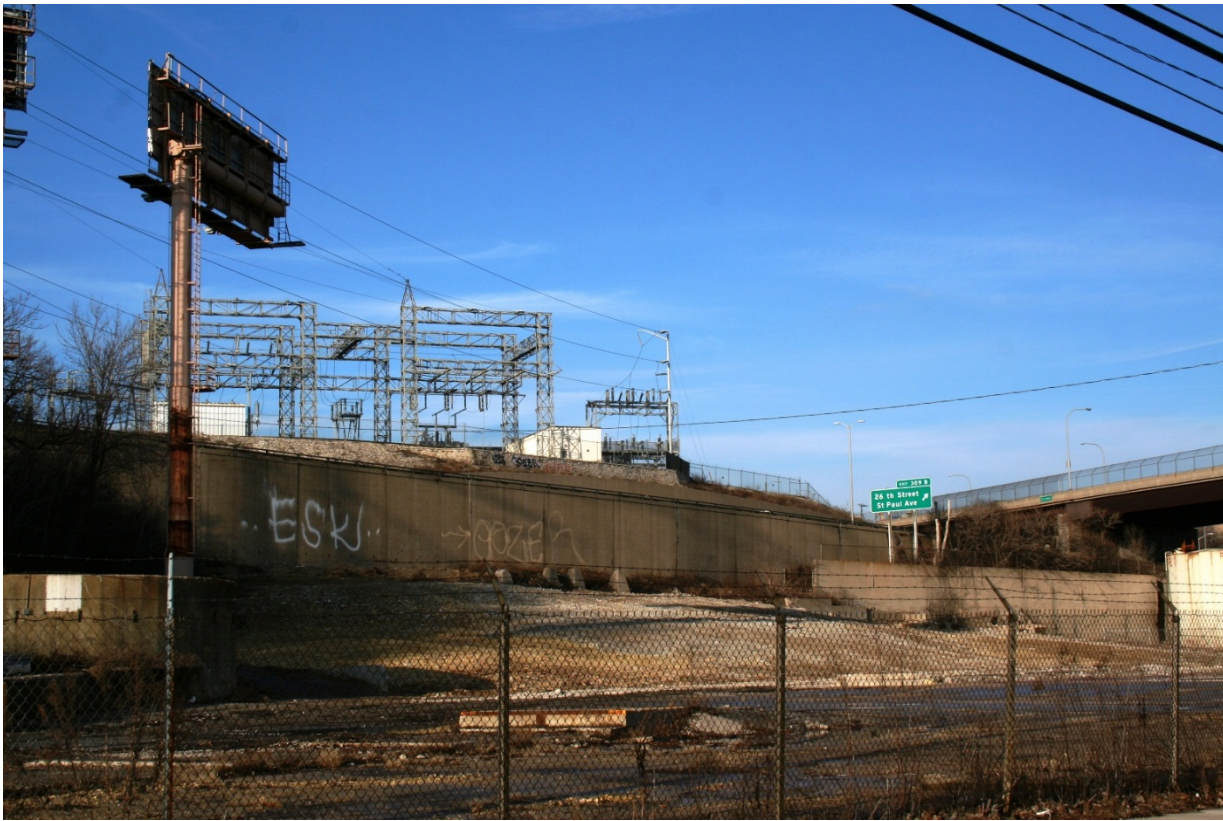
Exhibit A-25: Location 23 (Landscape Unit 6) From W. Greves Street west of 27th Street looking northeast at I-94 retaining wall and S. 27th Street bridge over I-94.

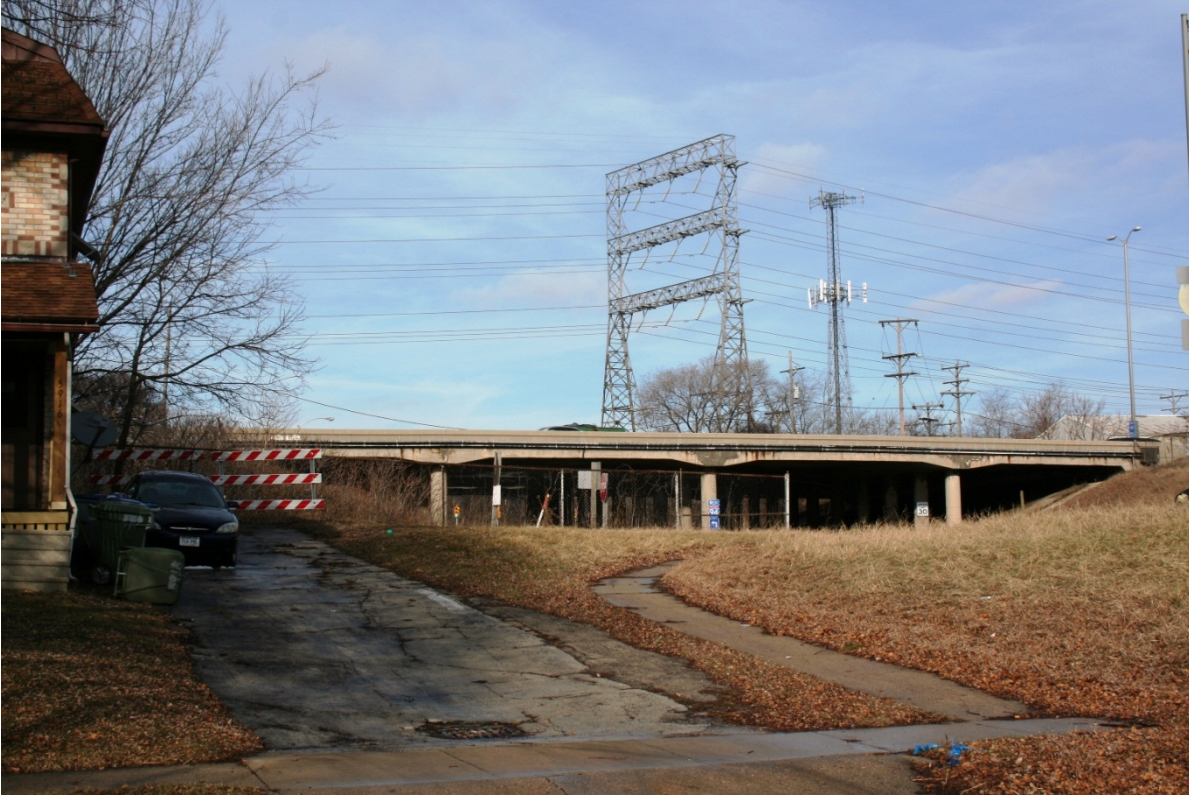
Exhibit B-3. KOP 1

Existing Condition: From Dixon Street west of Hawley Road looking northeast at I-94 overpass.

Visual Resource Survey:			Existing Conditions		
KOP Location:		West Dixon Avenue	Viewpoint:		KOP 1
Vividness					
Feature	Score*	Notes			
Landform	3	Slight topographic change seen.			
Vegetation	3	Sparse - most are trees on north side of I-94.			
Human-Made	3	The tall vertical 138 kV support structure is somewhat vivid from this location, but in reality is one af a number of structures along the transmission line alignment.			
Overall	3.0				
Intactness					
Overall	2	Structures seen from this location a utilitarian in use and appearance. 138 kV electrical transmission line structure is a large, vertical visual intrusion as is the overpass (but to a lesser degree becasue it has a horizontal form that is less visually contrasting than the support structure).			
Unity					
Overall	3	The long horizontal form of the I-94 overpass provides a bit of visual unity to this view, despite the variety of very different appearing visual elements that detract from the overall visual unity of this view.

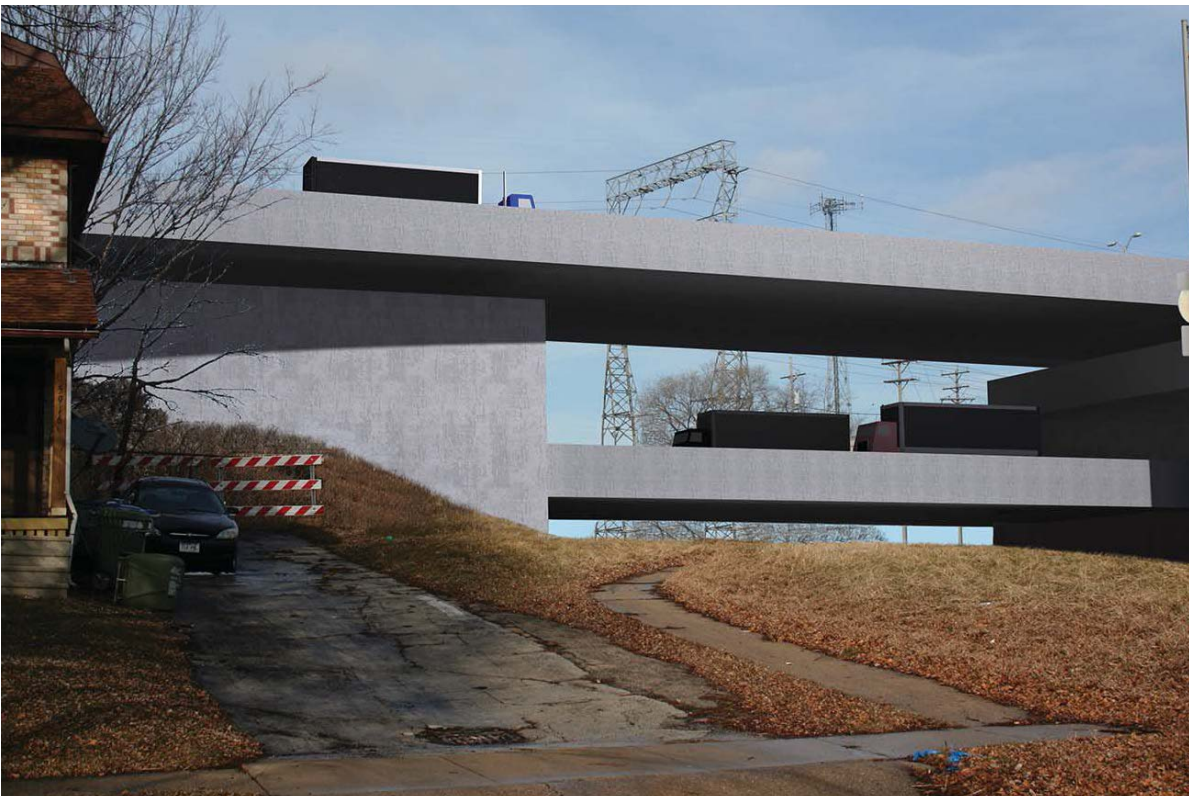
Simulation: Alternative W2 (C-D Roads).

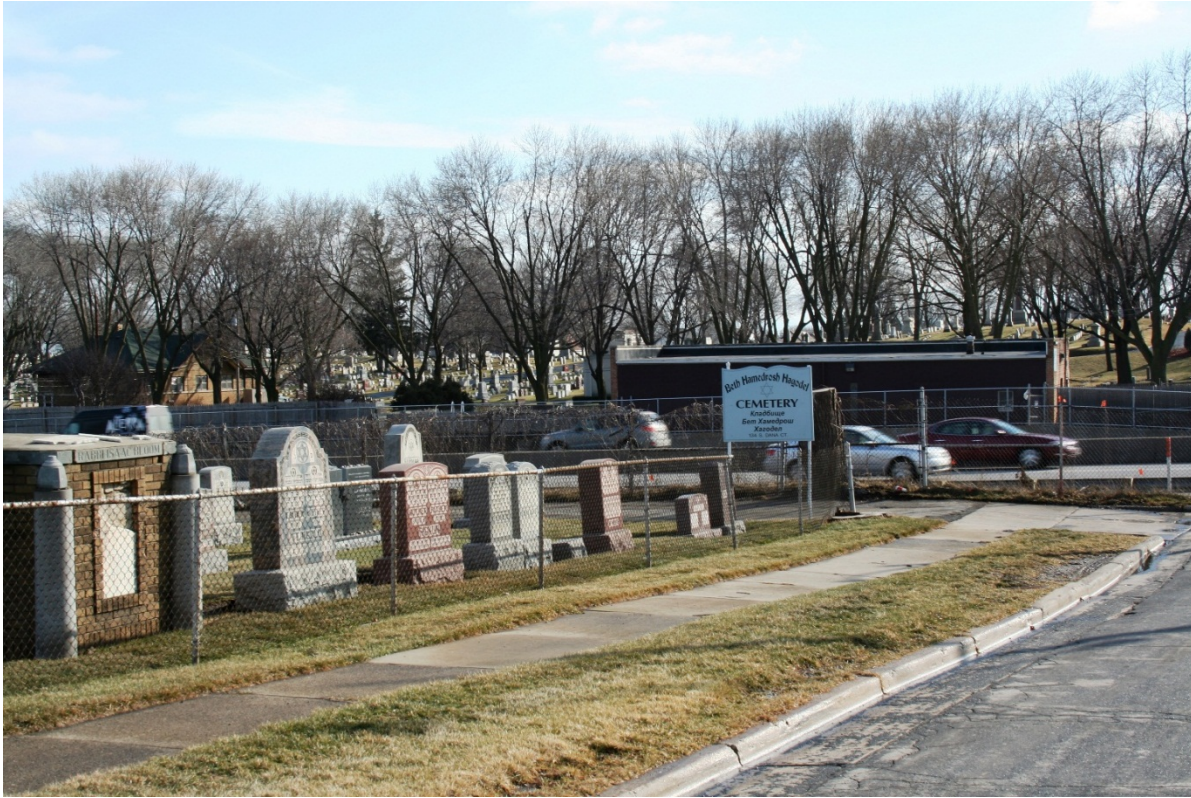
Exhibit B-4. KOP 2

Existing Condition: From Dana Court adjacent to Beth Hamedrosh Hagadol Cemetery looking south towards I-94 and Spring Hill Cemetery (note: Spring Hill Cemetery mausoleum – building behind white Beth Hamedrosh Hagol Cemetery sign).

Visual Resource Survey:			Existing Conditions		
KOP Location: Dana Ct. - Beth HH Cemetery			Viewpoint: KOP 2		
Vividness					
Feature	Score*	Notes			
Landform	5	See terrain beyond I-94			
Vegetation	5	Trees and lawns memorable.			
Human-Made	4	Headstones are memorable. Freeway, vehicles, and chainlink fence detract.			
Overall	4.7				
Intactness					
Overall	3.5				
Unity					
Overall	3	Freeway detracts from unity of views to cemetery beyond.			
Overall Visual Quality Score	3.7

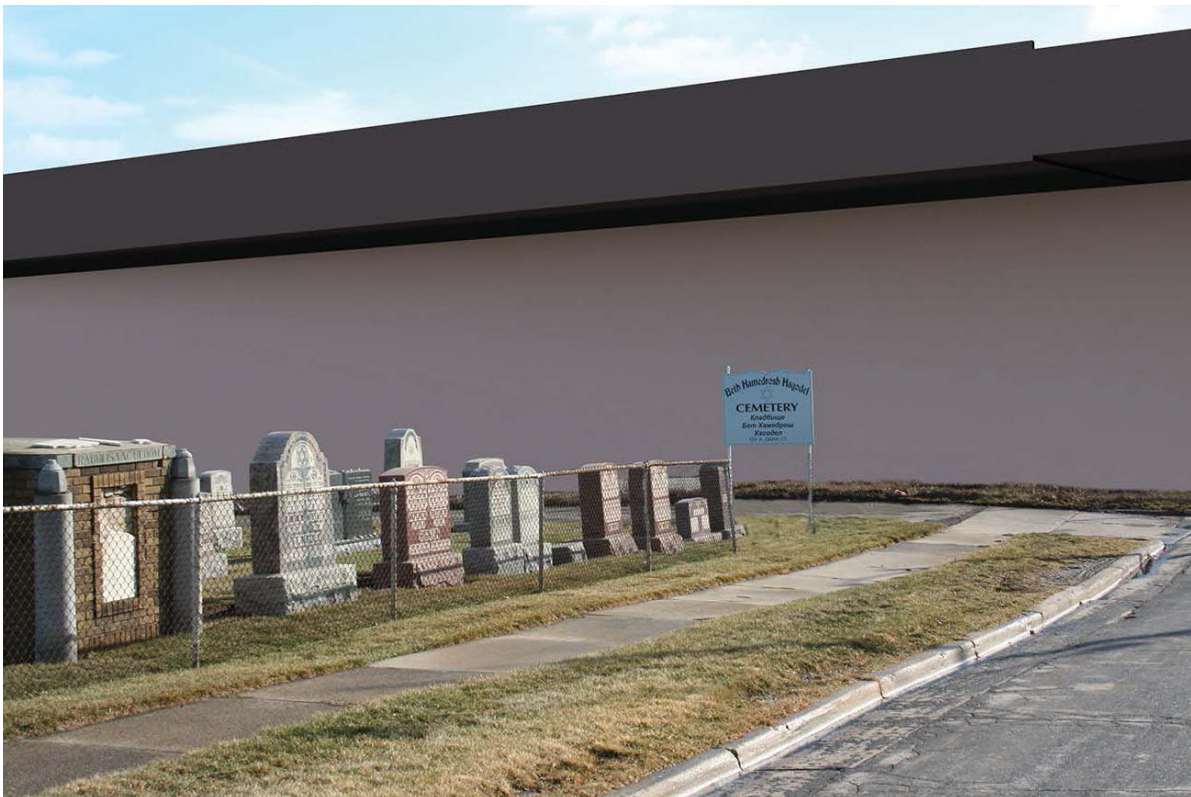
Simulation: Modified Alternative C5 (Double-Deck) with the All Up option.

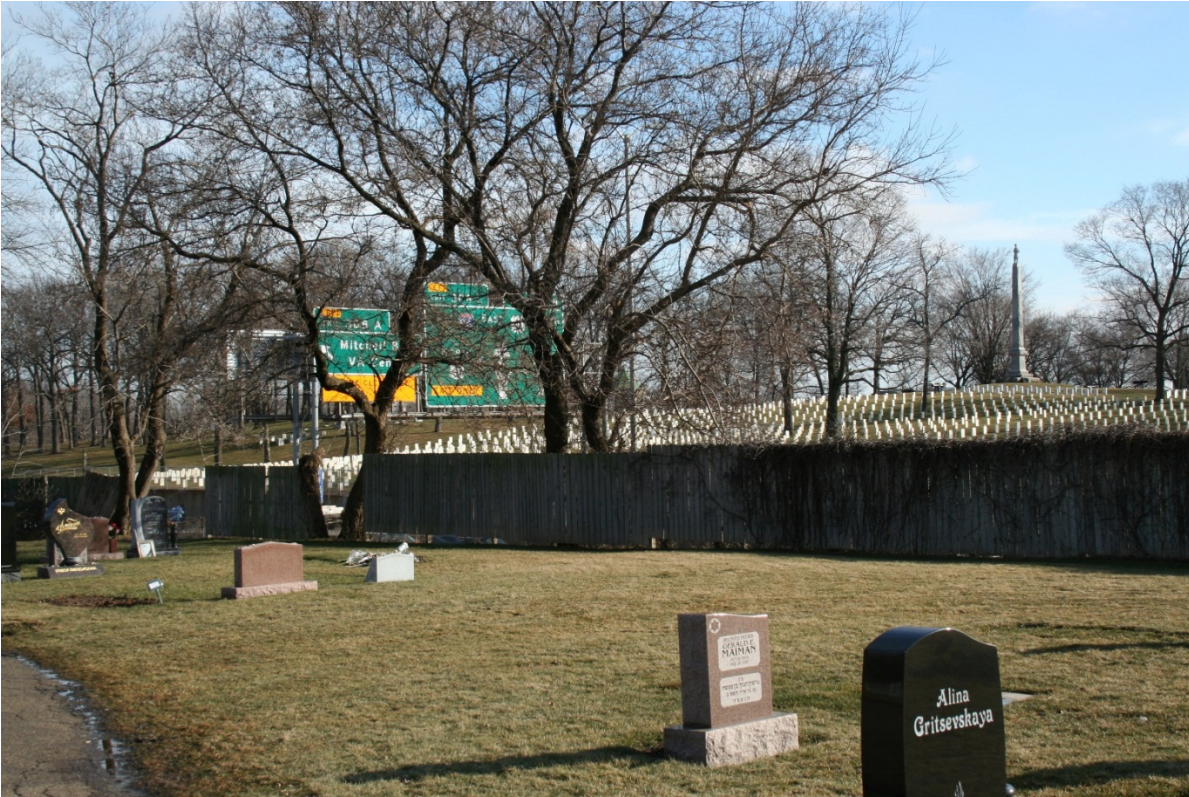
Exhibit B-5. KOP 3

Existing Condition: From east end of Beth Hamedrosh Hagodol Cemetery looking southeast at fence screening view of I-94 freeway lanes and main part of Wood National Cemetery.

Visual Resource Survey:			Existing Conditions	
KOP Location: Beth HH Cemetery			Viewpoint: KOP 3	
Vividness				
Feature	Score*	Notes		
Landform	5	Hill visible beyond I-94.		
Vegetation	5	Trees and lawn are somewhat vivid.		
Water Feature	NA			
Human-Made	5	Cemeteries are positive elements, fencing and freeway signs detract.		
Overall	5.0			
Intactness				
Overall	4	Fencing and signs somewhat detract from overall view intactness.		
Unity				
Overall	4.5	Views over freeway contribute to unity.		
Overall Visual Quality Score	4.5

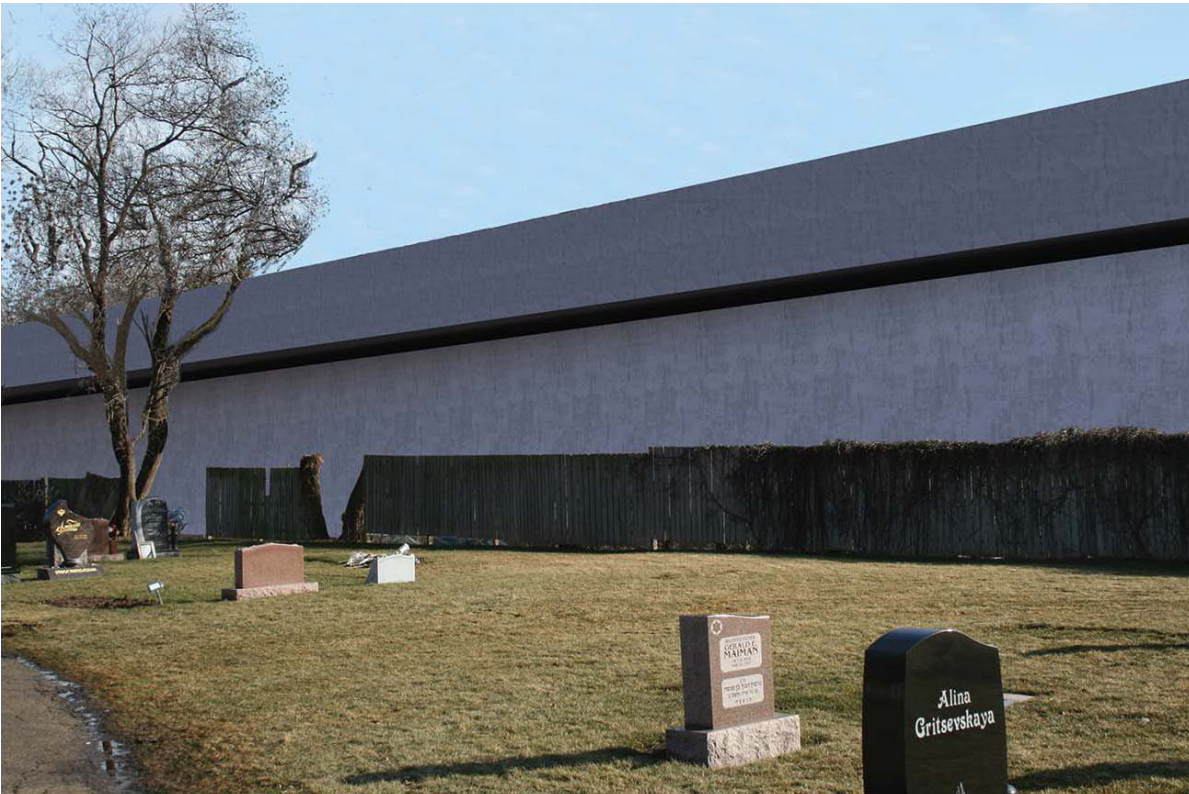
Simulation: Modified Alternative C5 (Double-Deck) with the All Up option.

Visual Resource Survey:		Alt. C5 - All Up Option	
KOP Location: Beth HH Cemetery			Viewpoint: KOP 3
Vividness			
Feature	Score*	Notes	
Landform	1	Views blocked.	
Vegetation	3	Remaining tree somewhat screens elevated structure.	
Water Feature	NA		
Human-Made	2	Views blocked and elevated structure is a large scale element. Condition of fencing more apparent.	
Overall	2.0		
Intactness			
Overall	2.5	Elevated structure is a large scale intrusion that blocks views.	
Unity			
Overall	3	Visual connection lost.	
Overall Visual Quality Score	2.5	Note that air flow openings in elevated structure would slightly increase visual connection between both sides of freeway and architectural detailing on openings and shape of openings would improve overall visual quality ratings by slightly increasing vividness and unity ratings.

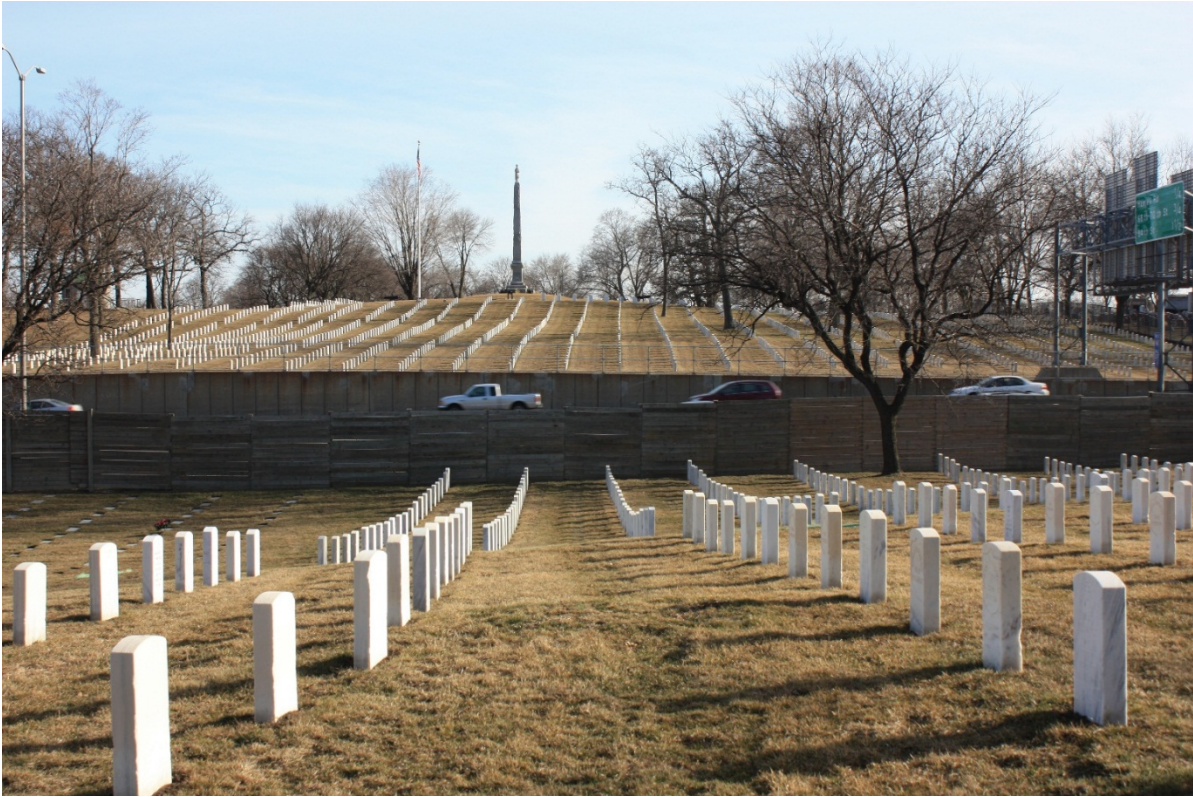
Exhibit B-6. KOP 4

Existing Condition: From Wood National Cemetery (north side of I-94) looking south at I-94 and main part of Wood National Cemetery beyond.

Visual Resource Survey:			Existing Conditions		
KOP Location: Wood National Cemetery (North of I-94)		Viewpoint: KOP 4			
Landscape Unit:					
Vividness					
Feature	Score*	Notes			
Landform	5.5	Slope south of I-94 very apparent.			
Vegetation	5.5	Lawn and trees create a uniform appearance, except where I-94 intrudes.			
Water Feature	NA				
Human-Made	5.5	Historic features visible on each side of I-94 and vehicles passing by on it.			
Overall	5.5				
Intactness					
Overall	4.5				
Unity					
Overall	5				
Overall Visual Quality Score	5.0

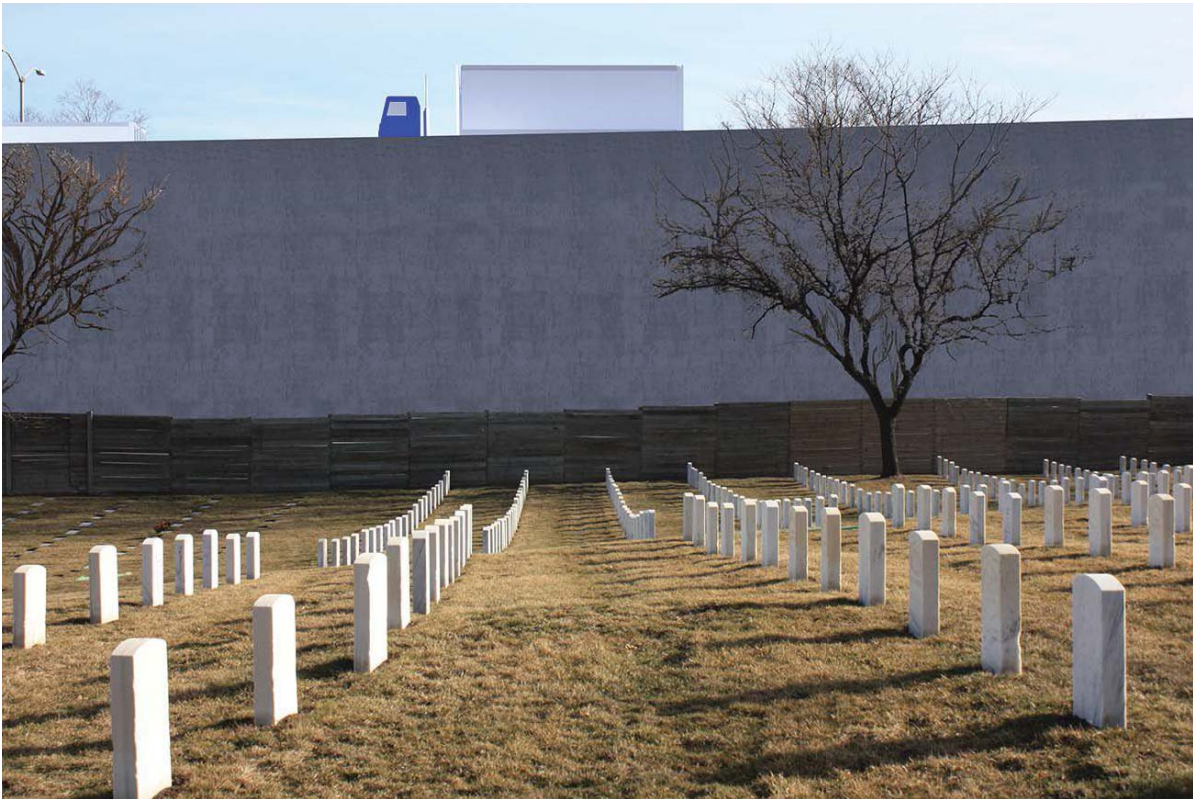
Simulation A: Modified Alternative C5 (Double Deck) with the All Up option.

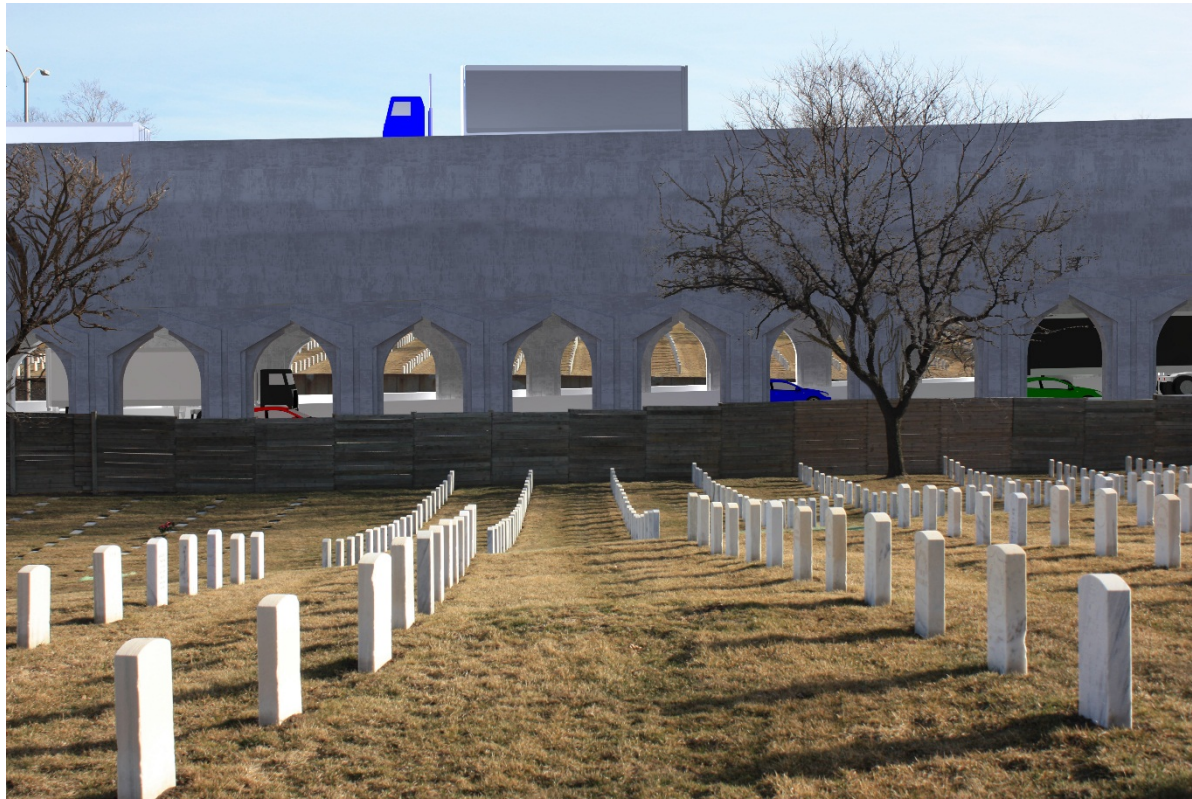
Simulation B: Modified Alternative C5 (Double Deck) with the All Up option and openings on the lower deck.

Visual Resource Survey:			Existing Conditions		
KOP Location: Spring Hill Cemetery		Landscape Unit:	Viewpoint: KOP 5		
Vividness					
Feature	Score*	Notes	Feature	Score*	Notes
Landform	5	Rolling terrain is visible on both sides of I-94.	Landform	1.5	View of terrain beyond I-94 blocked.
Vegetation	5	Trees and lawns in both cemeteries quite visible.	Vegetation	3	Tops of trees north of elevated structure can be seen as well as trees and lawn in Spring Hill Cemetery.
Water Feature	NA		Water Feature	NA	
Human-Made	5	Headstones in both cemeteries quite evident.	Human-Made	3.5	Although visual connection with Wood National Cemetery lost, headstones are still interesting features. Elevated structure and vehicles passing by detract from view.
Overall	5.0		Overall	2.7	
Intactness			Intactness		
Overall	4.5	Average to moderately high visual connection and intactness between both sides of I-94. .	Overall	2.5	Elevated structure intrudes on views.

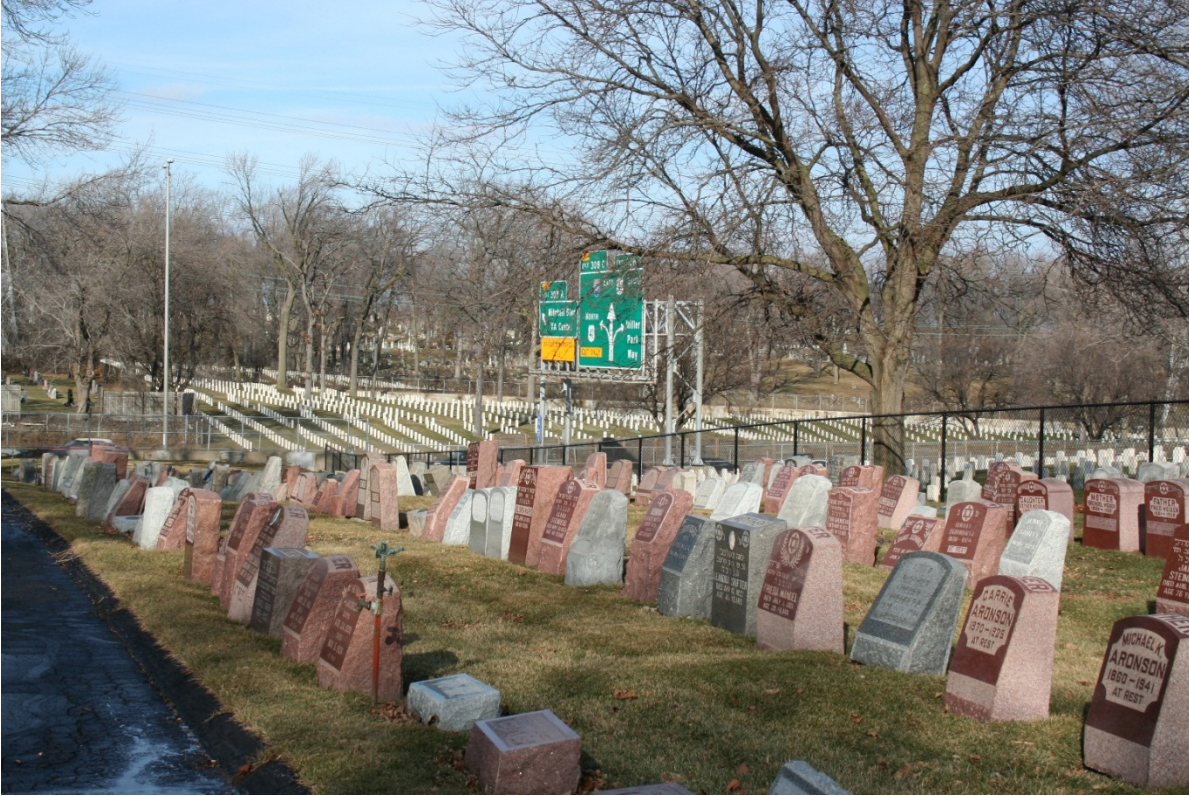
Exhibit B-7. KOP 5

Existing Condition: From Spring Hill Cemetery (east end next to Wood National Cemetery) looking north over I-94 at north parcel of Wood National Cemetery.

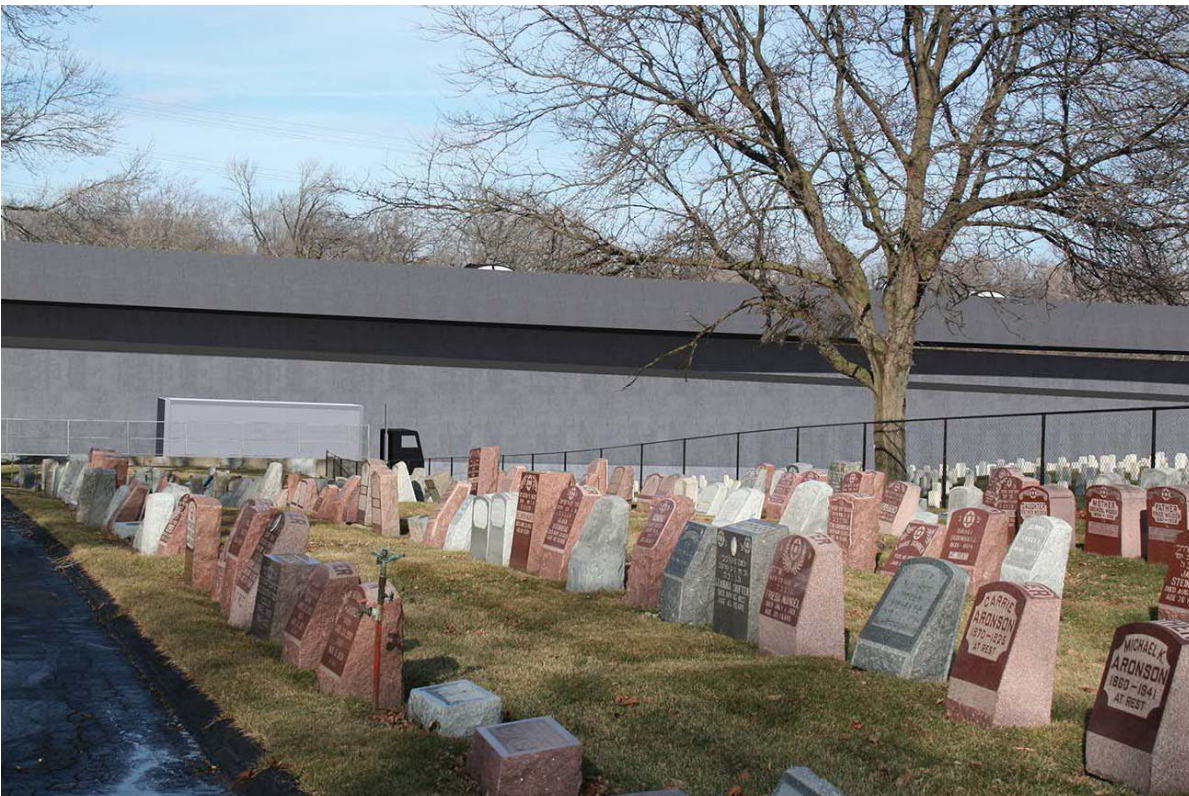
Simulation: Modified Alternative C5 (Double-Deck) with the All Up option.

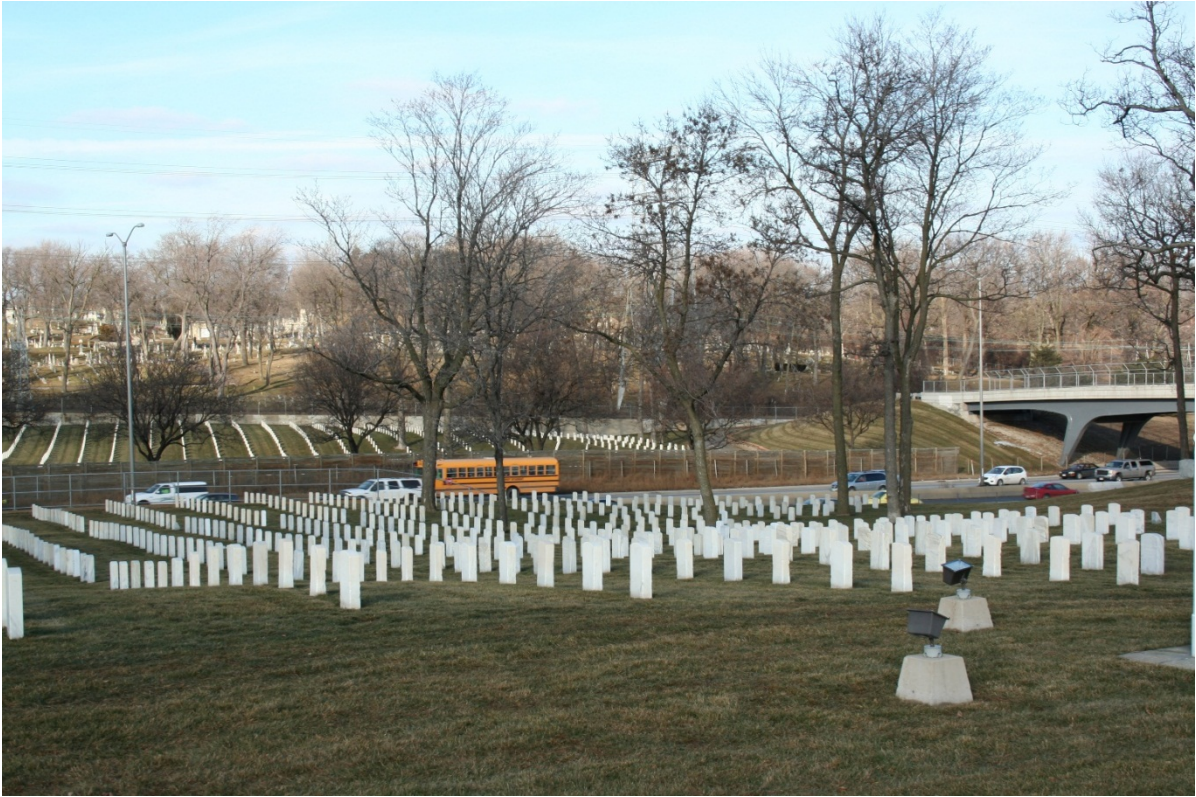
Exhibit B-8. KOP 6

Existing Condition: From Wood National Cemetery (south side of I-94) looking north at north parcel of Wood National Cemetery.

Visual Resource Survey:			Existing Conditions		
KOP Location:		Wood National Cemetery (south of I-94)	Viewpoint:		KOP 6
Vividness					
Feature	Score*	Notes			
Landform	4.5	Rolling terrain on both sides of I-94 very apparent.			
Vegetation	5	Lawns and heavy presence of trees on both sides of I-94.			
Human-Made	4	Cemetery components and I-94, vehicles passing on it, and an overcrossing compete for attention.			
Overall	4.5				
Intactness					
Overall	3.5	Freeway, vehicles, and overpass intrude on this view.			
Unity					
Overall	4.5	Despite freeway, vehicles and overpass, higher than average unity between cemeteries.			
Overall Visual Quality Score	4.2

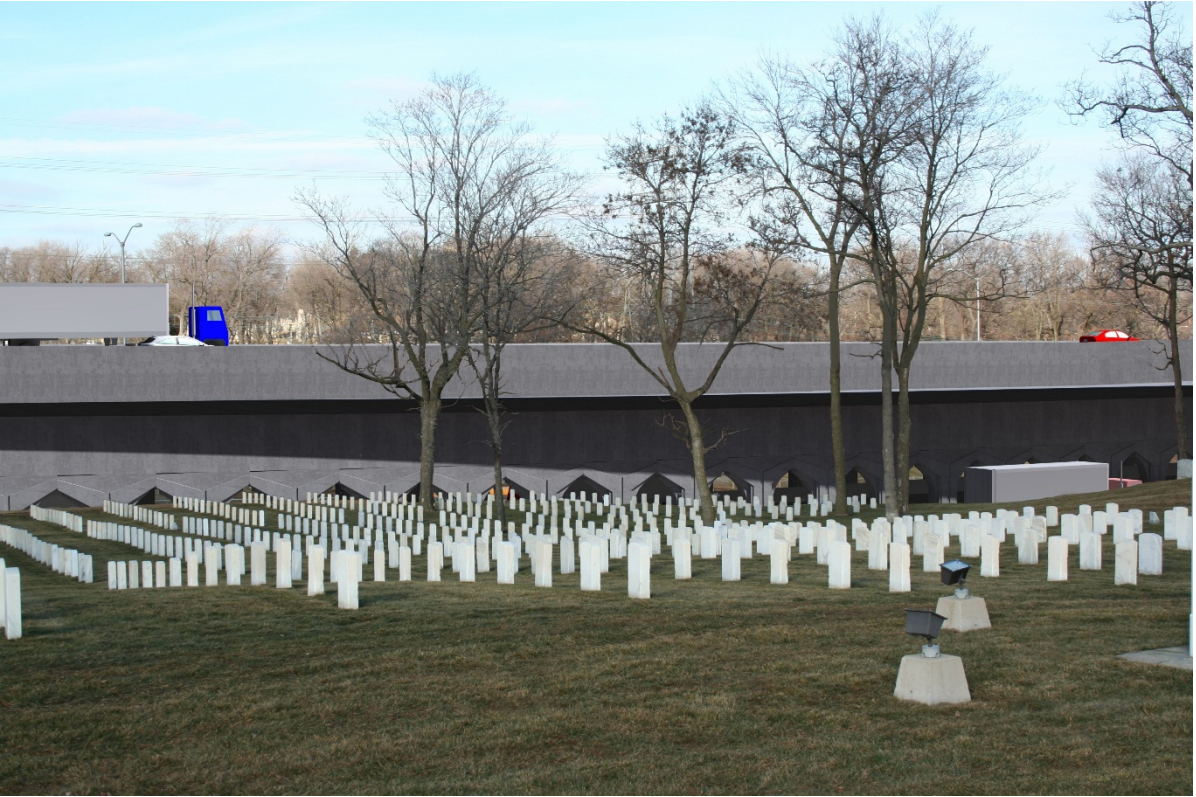
Simulation B: Modified Alternative C5 (Double-Deck) with the Partial Down option and openings on the lower deck.

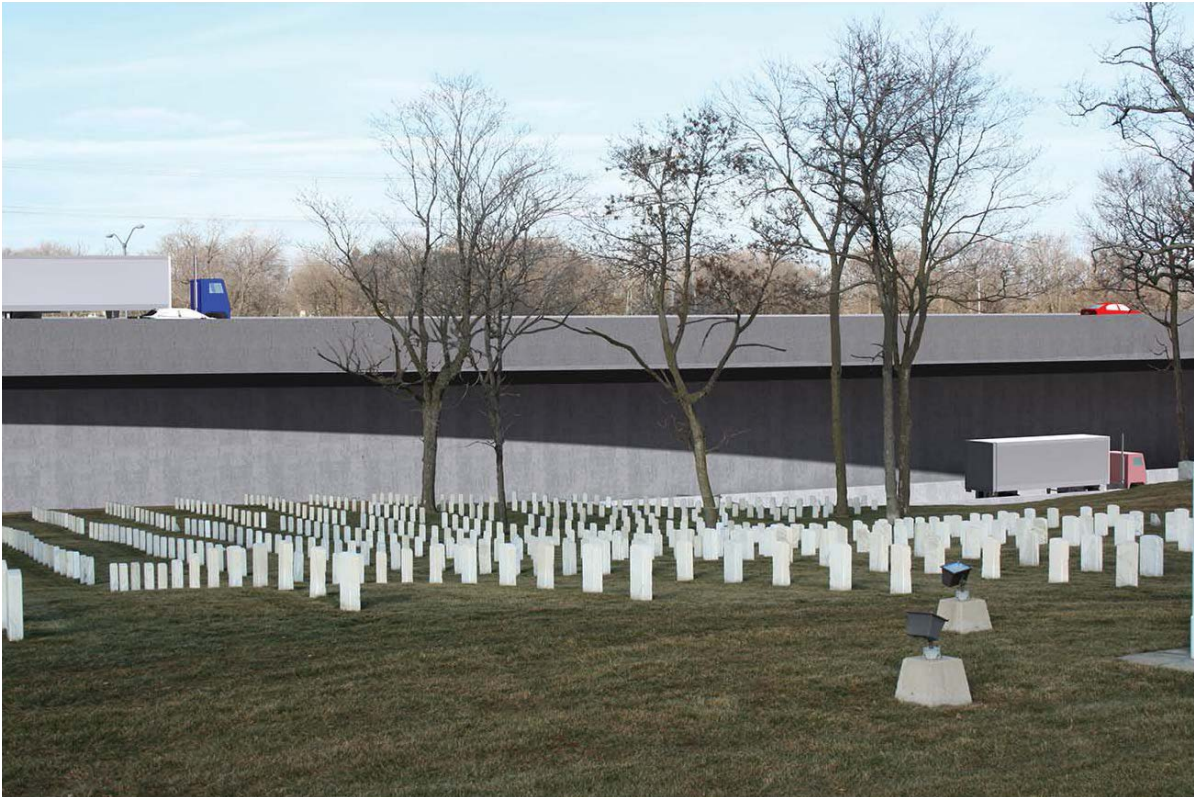
Simulation A: Modified Alternative C5 (Double-Deck) with All Up option.

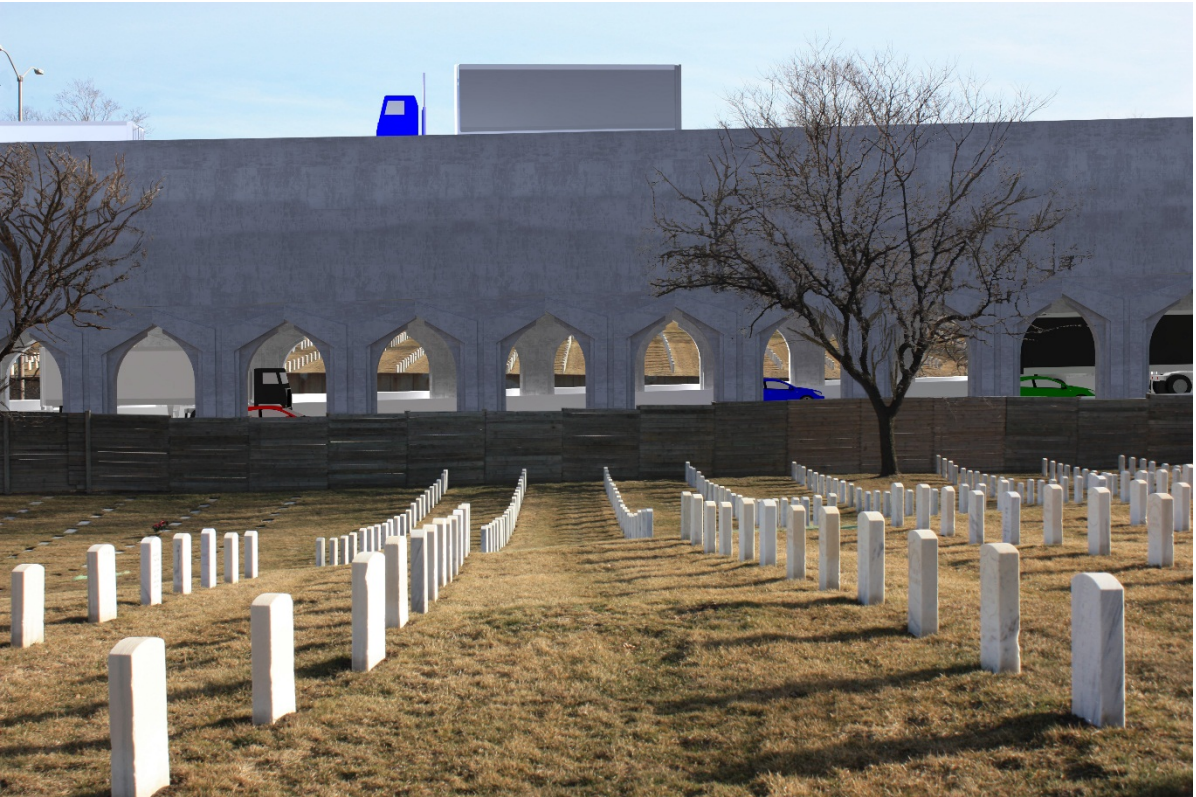
Simulation C: Modified Alternative C5 (Double-Deck) with All Up option and openings on the lower deck.

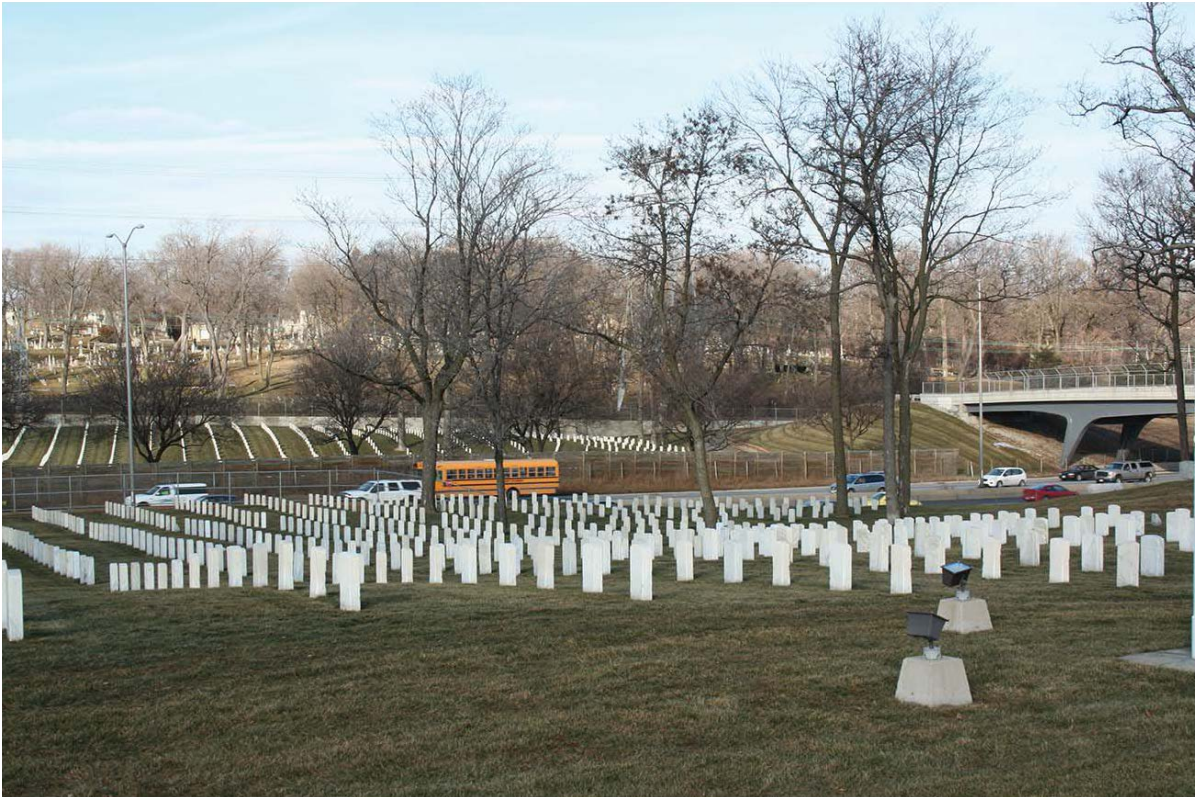
Exhibit B-8. KOP 6 (continued)

Existing Condition: From Wood National Cemetery (south side of I-94) looking north at north parcel of Wood National Cemetery.

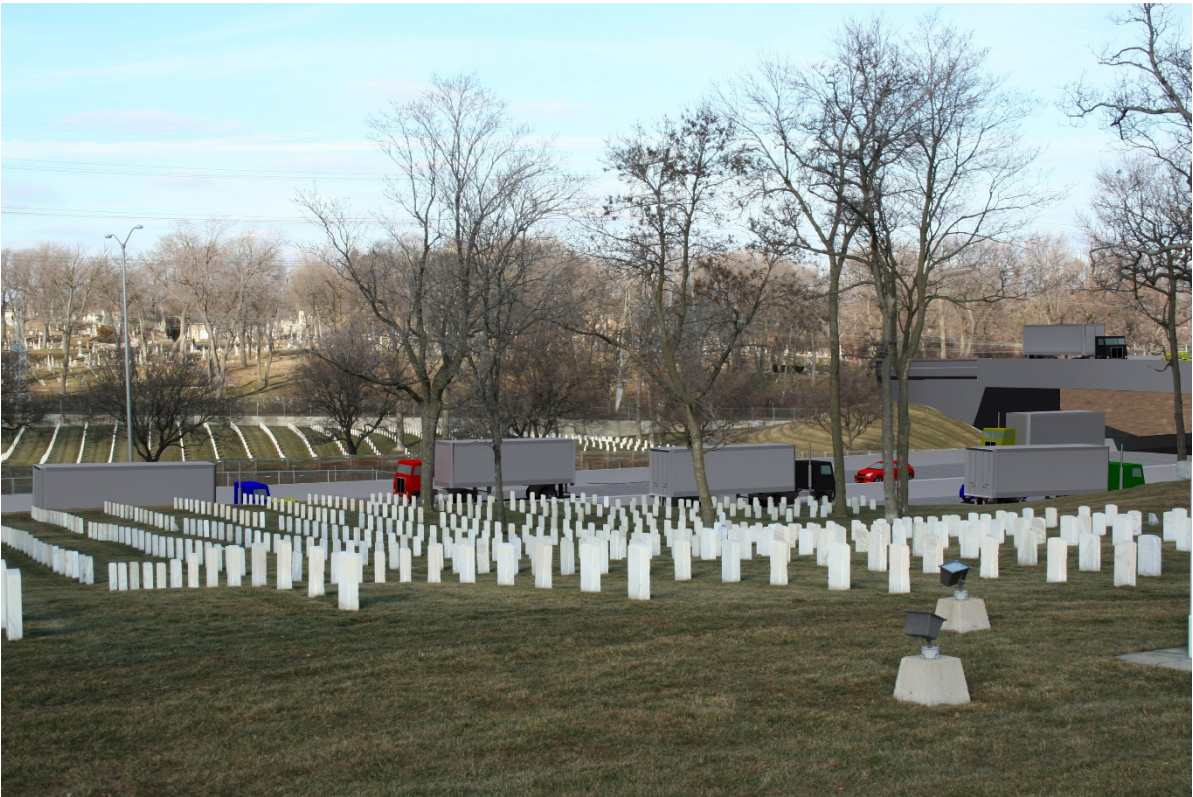
Simulation E: Modified Alternative C2 (At Grade) with connection to VA from Mitchell Boulevard south of I-94.

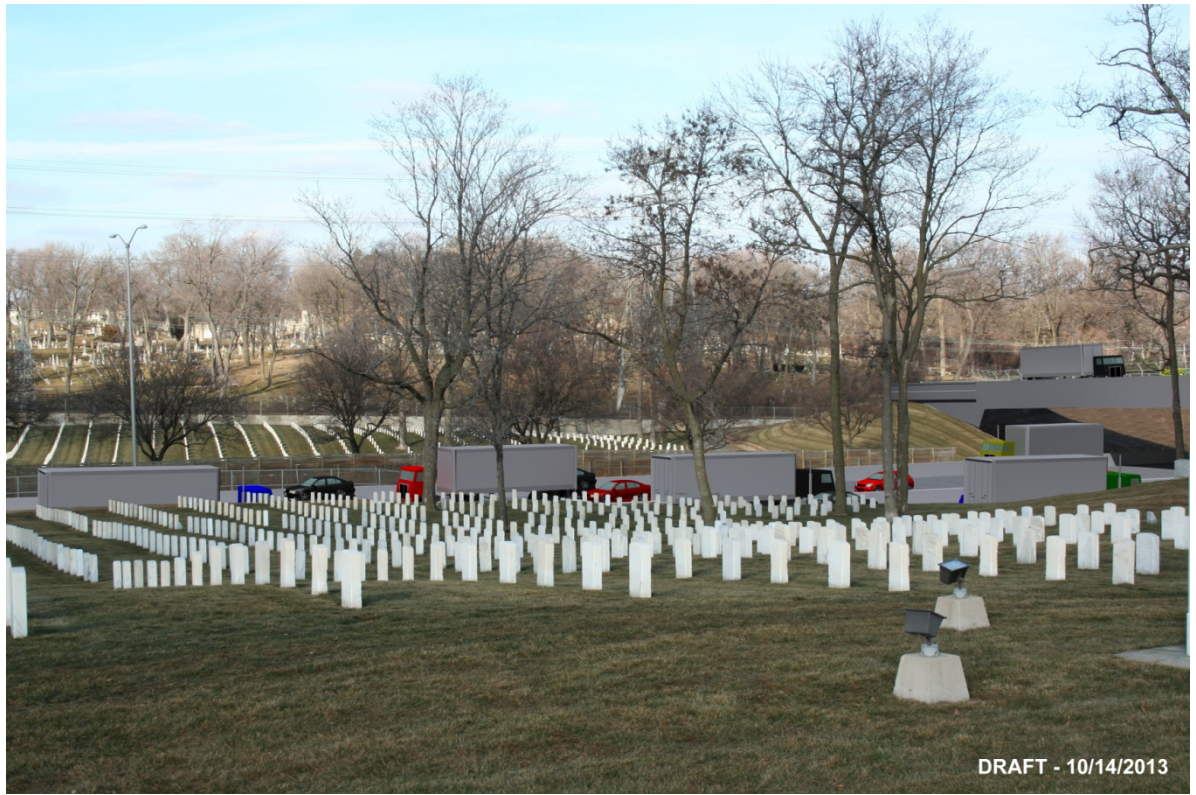
Simulation D: Modified Alternative C2 (At Grade) with no connection to VA from Mitchell Boulevard south of I-94.

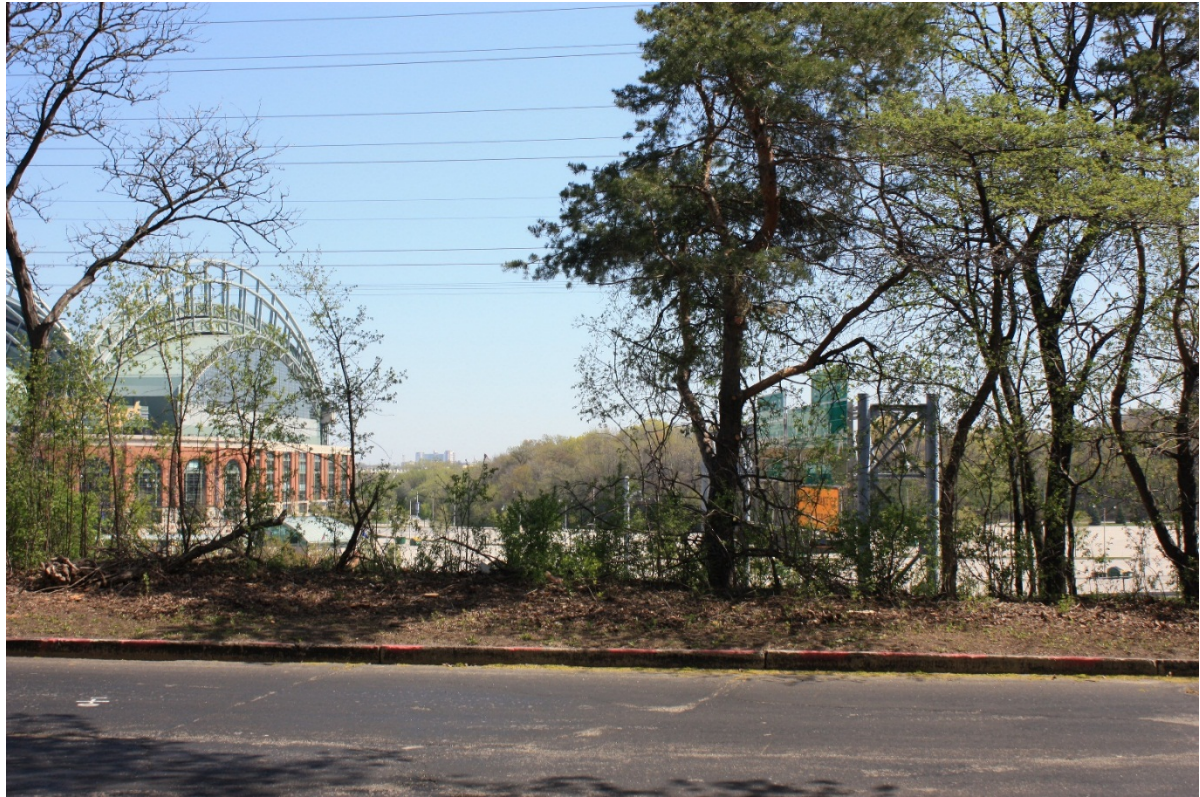
Exhibit B-9. KOP 7

Existing Condition: From Story Parkway looking southeast towards Miller Park and parking areas.

Visual Resource Survey:		Existing Conditions	
KOP Location: N. Story Hill Parkway (west)		Viewpoint:	KOP 7
Vividness			
Feature	Score*	Notes	
Landform	4.5	During leaf-off condtions, buidlings I the valley beyond I-94 and hillsides beyond can be seen.	
Vegetation	5	Vegetation along side the parkway as well as vegettion on the hillsides to the south south (seen during leaf-off condtions) are important parts of this view.	
Water Feature	NA		
Human-Made	5.5	Miller Park is an interesting visual elememnt. Signs associated with I-94 and the roofs of commercial - industrail buildings in the valley below I-94 detract from the view during leaf-off conditions.	
Overall	5.0		
Intactness			
Overall	3.5	The view includes a variety of viewed elements that taken together have lower than average intactness.	
Unity			
Overall	3.5		
Overall Visual Quality Score	4.0

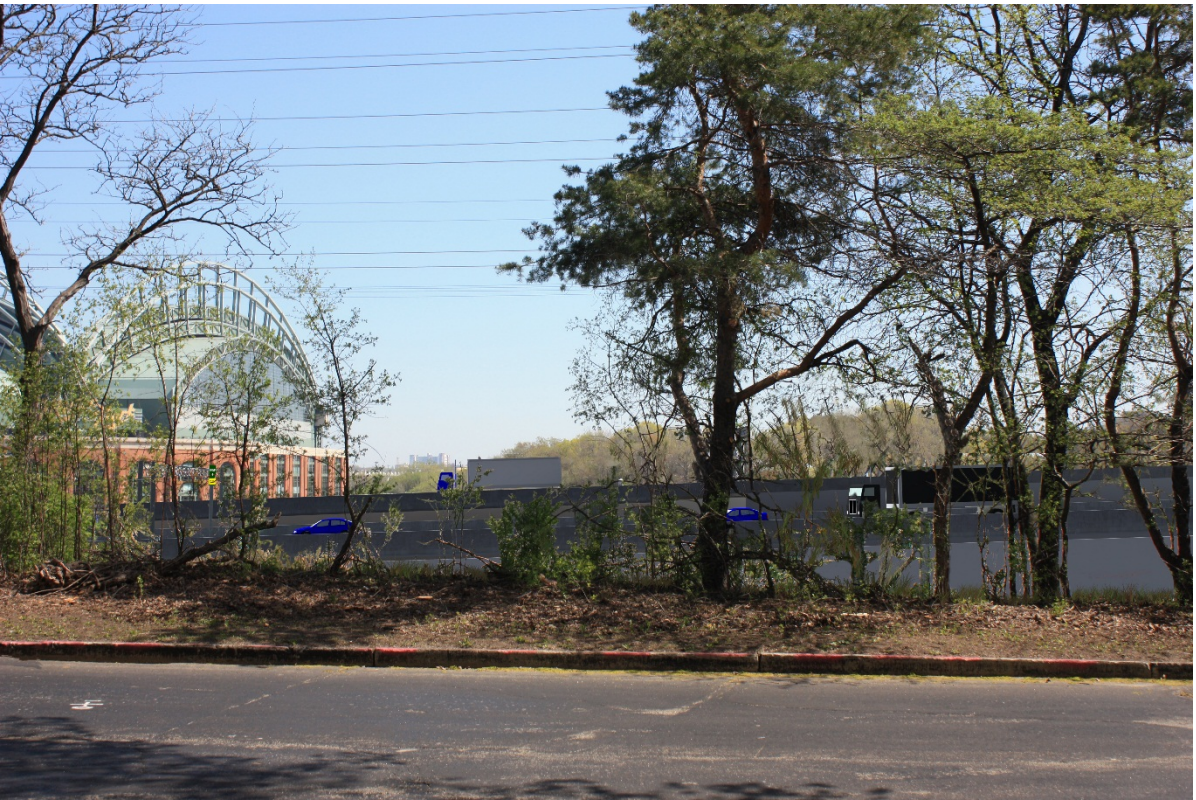
Simulation: Modified Alternative C5 (Double Deck) with the Partial Down option.
